Significant Road Safety Deficiencies in the Southern Lantau Road Network

Road Safety Commentary

by Julian TH Kwong 2015 10 13

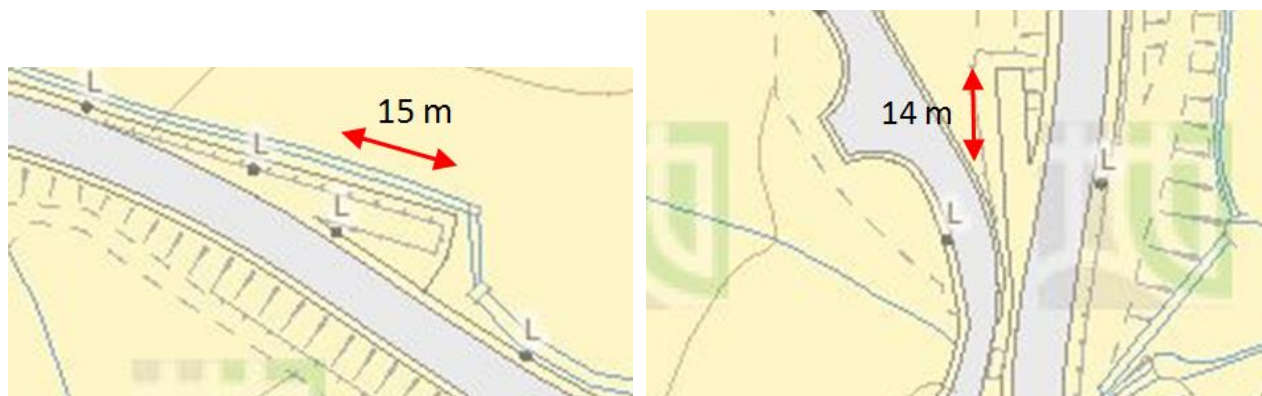
The arrester beds on Tung Chung Road measure only 14m and 15m in length whereas a proper facility would be 70m to 130m long, depending on the precise design parameters. Furthermore, the arrester beds do not consist of any proper treatments at the end. Signing and delineation are crucial to reassure and guide drivers under panic condition but the adequacy of these provisions is doubtful. In fact, a heavy vehicle or bus with brake failure is likely to overrun these arrester beds. The scenario of a fully loaded bus with brake failure attempting to use the facility at full speed could be catastrophic.

Layout and Dimensions of Arrester Bed for Southbound Traffic (left) and Northbound Traffic (right) (source of map: Lands Department)

It will be necessary to review the suitability of the location of these arrester beds and to reconstruct them to meet specific technical requirements. In the interim, these arrester beds should be closed off while alternative control measures are formulated to reduce the risk of brake failures.

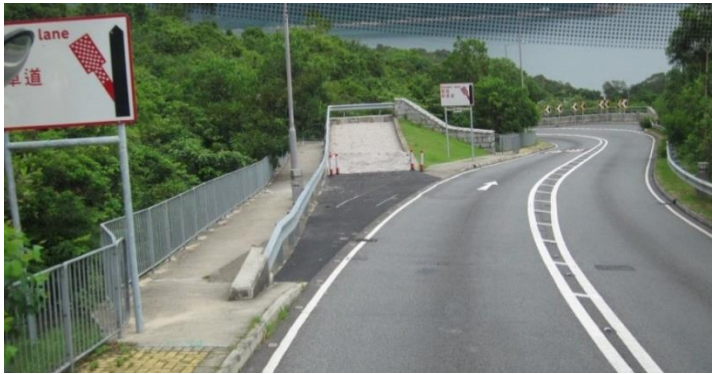
General View of the Arrester Bed for Southbound Traffic: Out-of-control vehicle is likely to overrun the facility and launched airborne into the forest

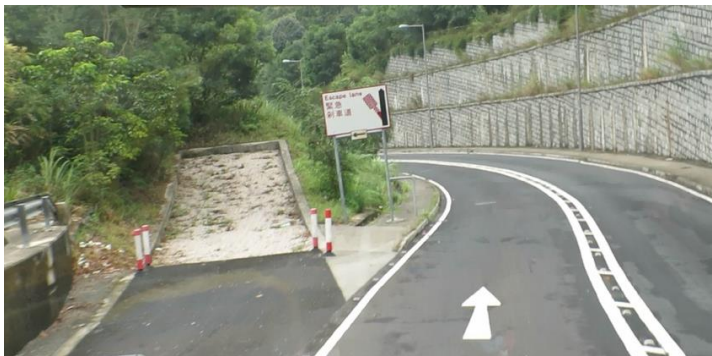
General View of the Arrester Bed for Northbound Traffic: Out-of-control vehicle is likely to overrun the facility and roll down the side slope back onto the road

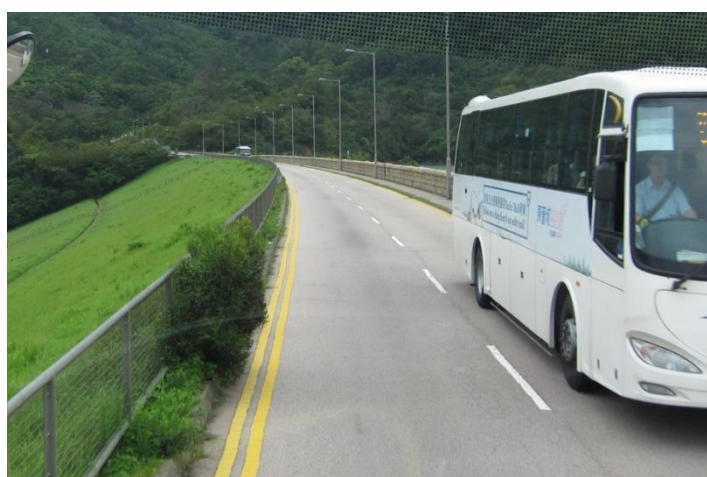
A 700m long section of Keung Shan Road lies along the crest of the dam of Shek Pik Reservoir. The northern roadside is guarded by a continuous stone wall but the southward roadside is guarded by a railing without the containment capability of a safety barrier. The dam is more than 50m in height and the southern side slope has an initial gradient of 1 : 2.275 (23.7 °) followed by 1 : 2.78 and then 1 : 3. Over the side slope there are three berms with drainage channels. The bottom of the slope is a massive toe wall.

From the roadside safety point of view, side slope gradient of 1: 3 and steeper will not permit an errant vehicle to regain control. The vehicle could readily roll over and may continue to fall off the slope. The intermediate berms and bottom toe wall could further aggravate the damage and casualties.

Steep Side Slope of the Dam without a Proper Safety Barrier

To rectify the problem, a continuous Thrie-beam safety barrier or equivalent should be installed along the entire length of the southern roadside of the dam.

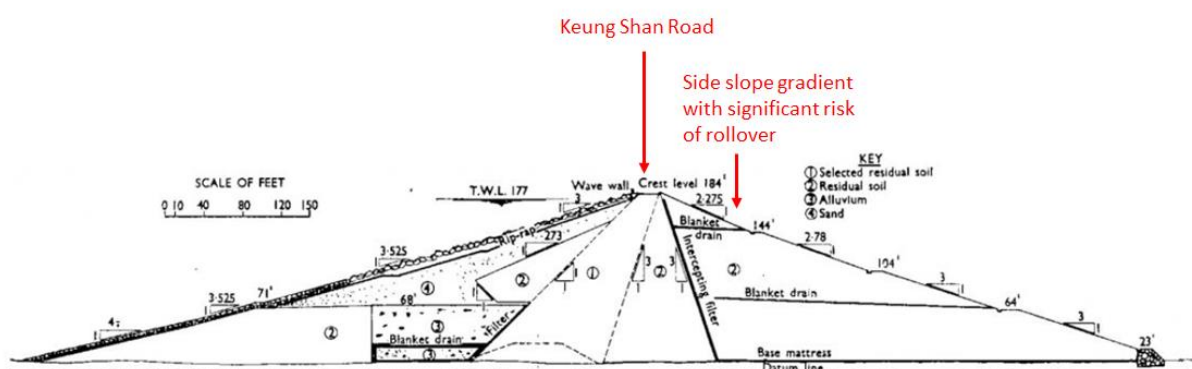
Cross-section of Shek Pik Reservoir (courtesy: Indhkh Group and Tymon Mellor; Government's archive)
