## Views

### **A bus-pedestrian Collision at Sha Tin New Town Plaza Bus Terminus**

### **Construction Waste Tipper is a Road Safety Hazard**

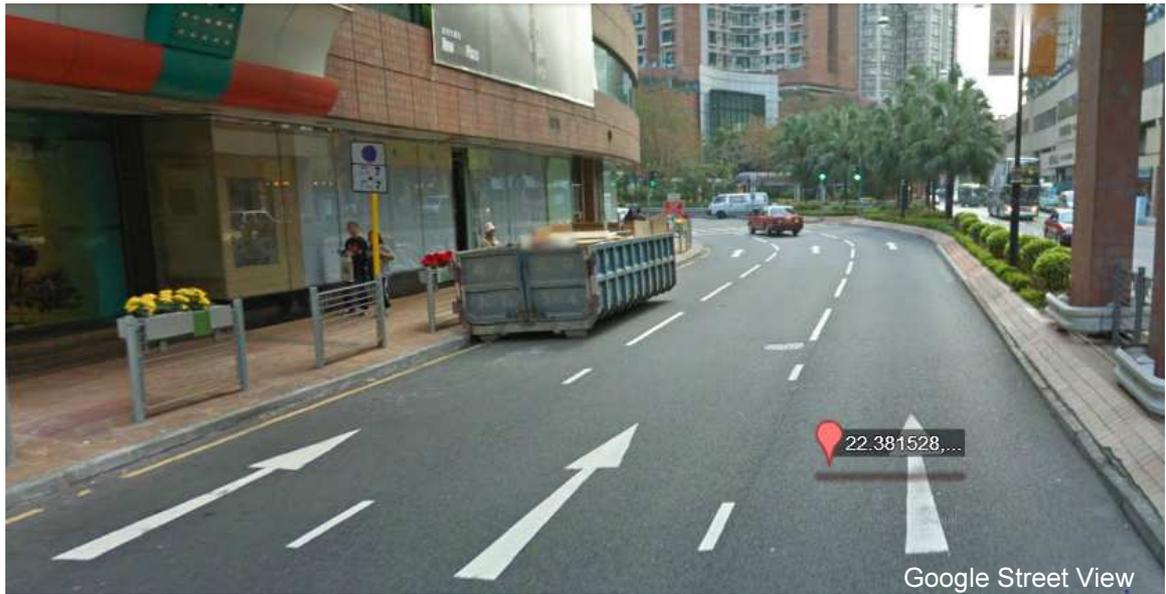
*A tipper with no reflective markers directly placed on the traffic lane of a distributor road*

Construction waste tippers are often placed on roadsides in Hong Kong. They are sometimes directly placed on a traffic lane, including main roads with relatively high traffic speeds.

These tippers are made of solid steel with a dull colour, and are therefore poorly visible to motorists. Collision with these tippers can result in severe casualties.

In Hong Kong, it is illegal to place a tipper on a street without authorization. Due to various reasons, however, tippers continue to be a common scene on the streets. From the road safety point of view, CRS considers that tippers are potential hazards which must be given immediate attention. The authority should, at the minimum, requires that the sides of a tipper are marked with reflective strips. Additionally, immediate enforcement should be taken for tippers in the following situations:

- On a traffic lane where speeds could exceed 40km/h
- On a layby where speeds where speeds could exceed 50km/h
- Located after a visual blockage e.g. blind bend, crest top

Where immediate removal is not possible, advance placement of a traffic cone or similar delineator will be essential.
